# Problem of Clogging in Drainage Systems in the Examples of the Żur and Podgaje Dams

Witold Sterpejkowicz-Wersocki

Gdańsk University of Technology, Faculty of Civil and Environmental Engineering,  
ul. G. Narutowicza 11/12, 80-233 Gdańsk, Poland, e-mail: wste@pg.gda.pl

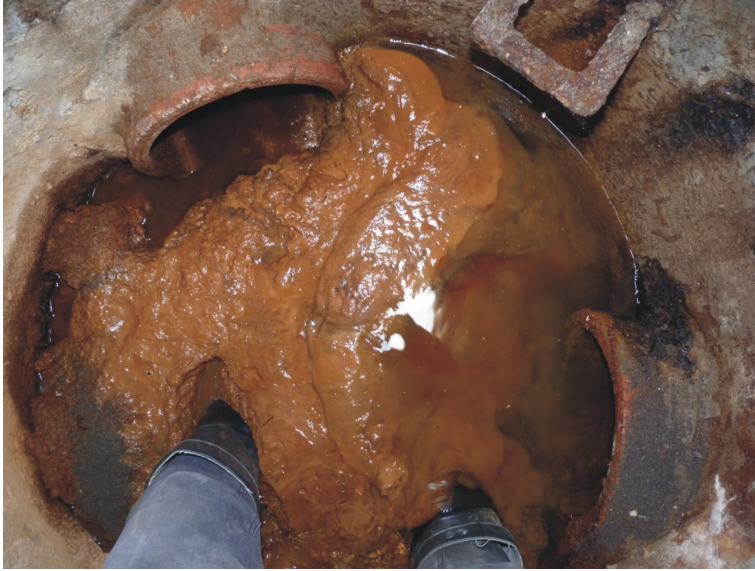
During operation, a slow but steady increase in pressure filtration can be observed. Inside wells and drainage pipes, clogging is caused by iron oxide in the form of fer-

**Fig. 3.** Ferruginous substance in a well

ruginous deposits, which reappear within a few months after being removed (Fig. 3 and Fig. 4).

The technical condition of the drain and the observed upward trend of the phreatic curve clearly demonstrate the need to restore the drainage system. Under the existing conditions, it is impossible to protect the drain effectively against the precipitation of iron oxide, but measures should be taken to delay the consequences of progressive clogging.

These measures include the replacement of the geotextile as a drainage layer with classic mineral inverted filters. The author's experiences (Bolt, Sterpejkowicz-Wersocki 2006; Sterpejkowicz-Wersocki Szudek 2011, 2013; Sterpejkowicz-Wersocki 2013) regarding the effectiveness of geotextiles in filtration and drainage solutions indicate that the presence of ferruginous groundwater results in the formation of an impermeable film on the surface of geosynthetics. In other cases, geotextiles retain their function, acting effectively as filters.

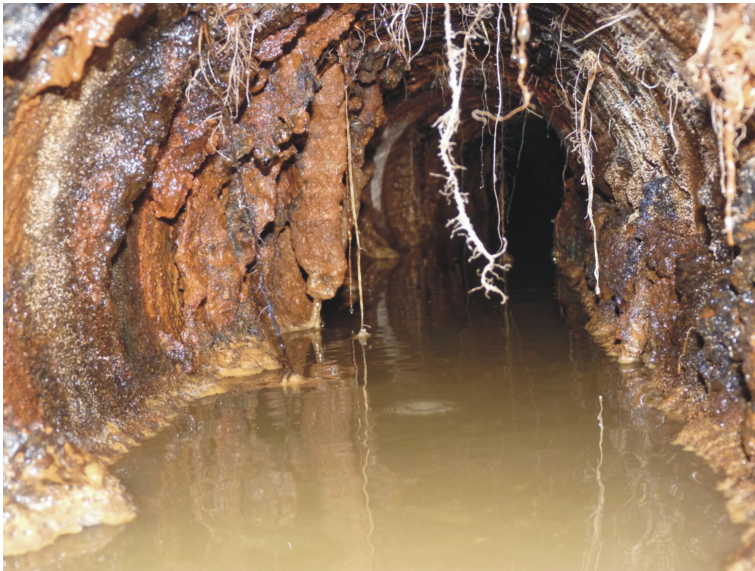
**Fig. 4.** Ferruginous substance in a pipe

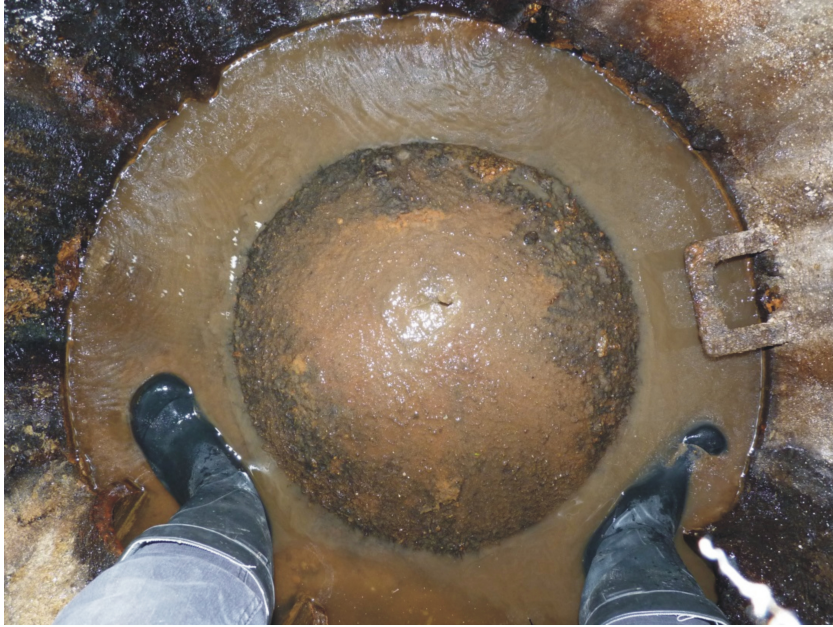
Some of the drainage wells have been mounted only on a geotextile (without a concrete plug). Inside the wells, a severe clogging of the geotextile can be observed, which

results in a bulge of the material (Fig. 5) caused by groundwater pressure, which is stabilized at a height of about 2 m above the bottom of the well.

**Fig. 5.** A bulge caused by groundwater pressure in geotextile at the bottom of a well
