# Problem of Clogging in Drainage Systems in the Examples of the Żur and Podgaje Dams

Witold Sterpejkowicz-Wersocki

Gdańsk University of Technology, Faculty of Civil and Environmental Engineering,  
ul. G. Narutowicza 11/12, 80-233 Gdańsk, Poland, e-mail: wste@pg.gda.pl

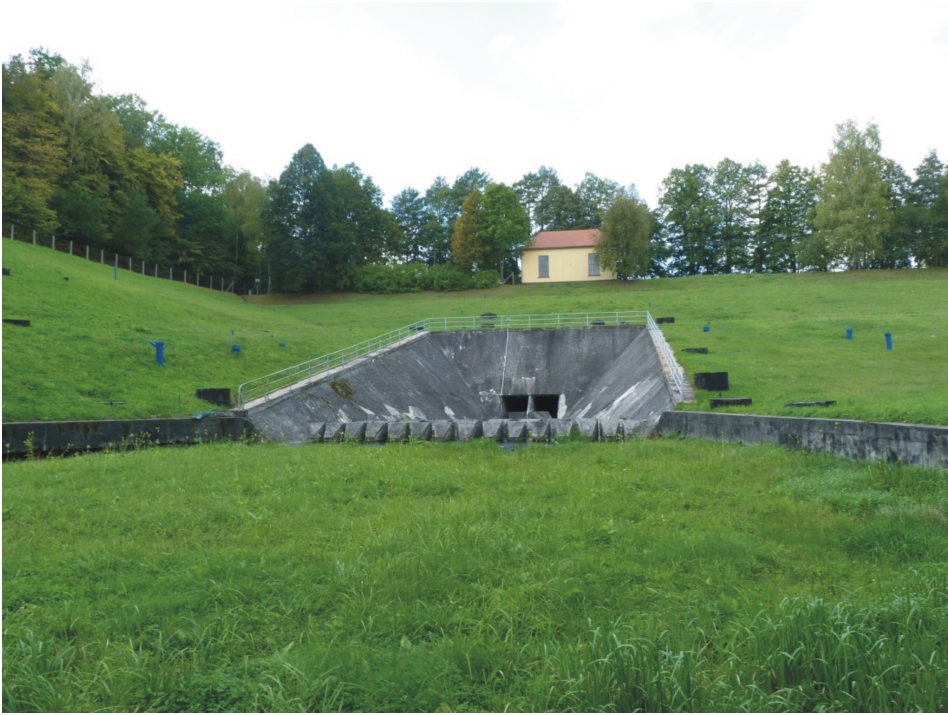
In the mid 1970s, a decision was made to build a new drainage system, as the rock toe filter had been clogged, and it was pointless to renovate the filtration capacity

**Fig. 1.** General view of the Zur earth dam and the bottom outlet

of the rip-rap that had worked since the beginning of the construction. There is no further information about the type of clogging. It was probably related to the development of vegetation, with layers of soil and root, and the consequent reduction in the permeability of the drainage prism at the base of the downstream slope of the dam.

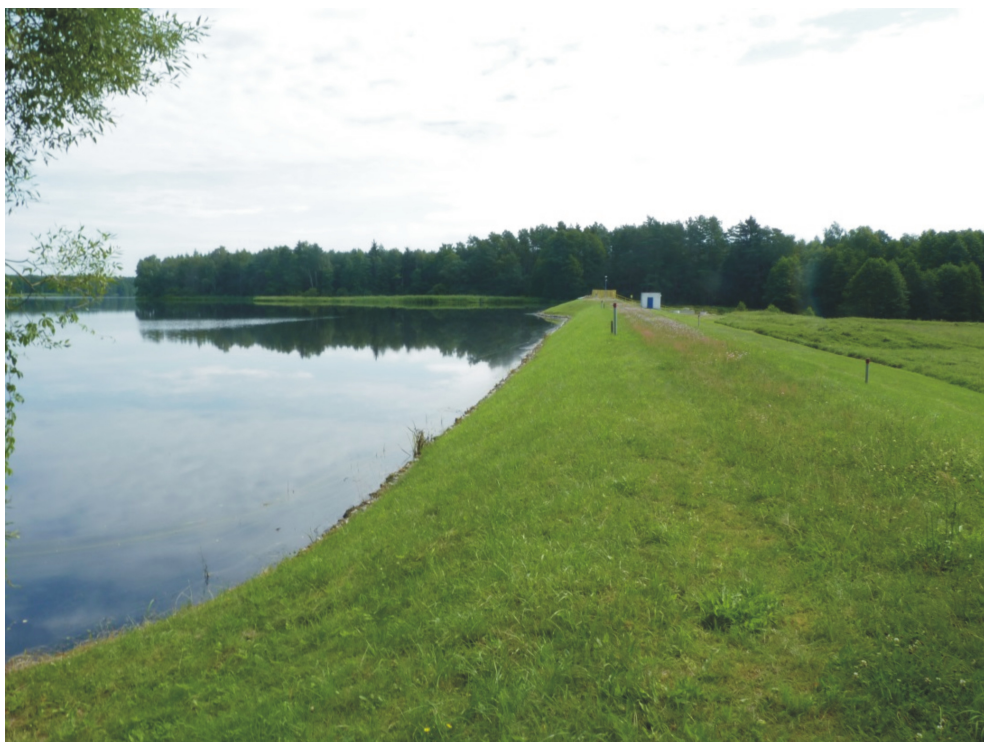
**Fig. 2.** General view of the Podgaje earth dam

This earth dam is also afflicted with cyclical drainage dysfunctions caused by clogging with iron compounds. Its present drainage system was constructed in 1991. It consists of ceramic drainage pipes, a sand filter, and a geotextile.

During operation, a slow but steady increase in pressure filtration can be observed. Inside wells and drainage pipes, clogging is caused by iron oxide in the form of fer-
